Monitoring Data RecordProject Title: Henderson Western Loop (U-2527) COE Action ID: 199708127Stream Name: UT to Red Bud Creek DWQ Number: 031494City, County and other Location Information: Henderson, Vance County
(Sta. 40+80 to 47+20)

Water was turned into stream on 6/13/05. Planting was completed on 3/10/06.Monitoring Year: (2) of 5Ecoregion: _____ 8 digit HUC unit 03010102

Year 2 Summer – June 2007

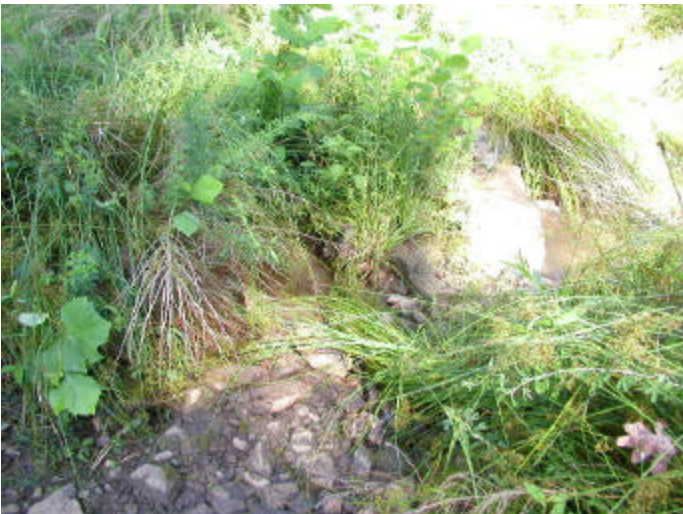
Cross Vane Located @ Sta. 41+20

The stream is highly stabilized for the Year 2 summer evaluation. The minor bank erosion noted last year located at approx. Sta. 40+90 is stabilized with heavy herbaceous vegetation and warrants no remedial action at this time. All cross vanes are functioning properly except for a cross vane located at approx. Sta. 41+20. This cross vane has a headcut and water piping under the structure. NCDOT will continue to monitor this stream relocation.

6/6/07	Sta. 41+20	Station Number	Station Number	Station Number	Station Number
Structure Type	Crossvane				
Is water piping through or around structure?	Water is piping under the crossvane				
Head cut or down cut present?	Headcut				
Bank or scour erosion present?					
Other problems noted?
